Manhole Inspection Summary

Manhole # S13GG2001MH

Insp Date: **6/30/06 10:11 AM**

Location Address: **6001 BONNIE VIEW DR**

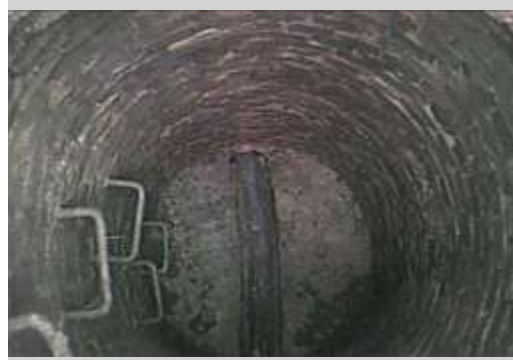
Top View

Bench debris.

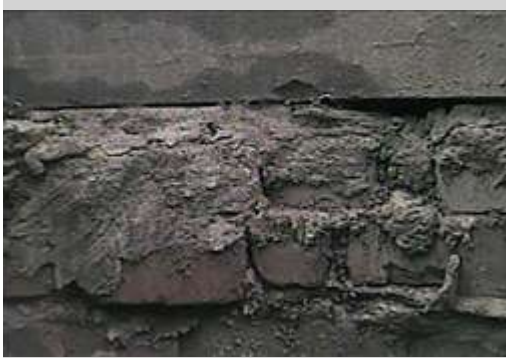
Defect

Frame Offset: **0** (in.) Condition: ☐ Sound ☐ Cracked ☒ **Leaks**

Condition: ☐ Sound ☐ Cracked ☐ Root Intrusion ☐ Loose Brick ☒ **Deteriorated**

Infiltration: ☐ None ☒ **Joint** ☐ Cracks ☒ **Mortar** ☐ Roots ☐ Wall

Frame leaks. Adjustment deterioration and infiltration.

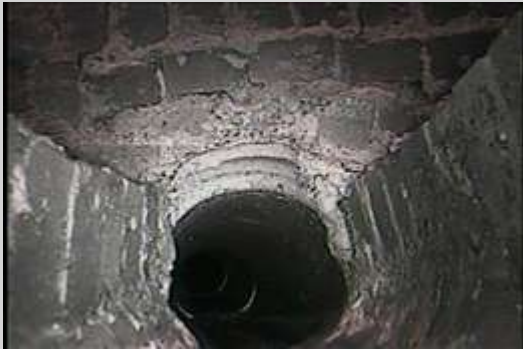
8 in. Circular Gravity Sewer Pipe Out @ 12 O'Clock

Pipe Material: **Clay** ☐ Pipe Lined

Invert Depth: **10.69** (ft.) Flow Characteristics: **Slow**

Infiltration: **None** Pipe Seal Cond: **Unknown**

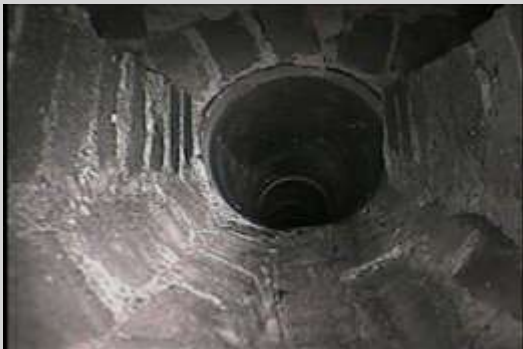
8 in. Circular Gravity Sewer Pipe In @ 6 O'Clock

Pipe Material: **Clay** ☐ Pipe Lined

Invert Depth: **10.16** (ft.) Flow Characteristics: **Slow**

Infiltration: **Evidence** Pipe Seal Cond: **Unknown**
